Final Report No. 1793

concerning the accident
to the aircraft AVRO 146-RJ100, HB-IXM,
operated by Crossair under flight number CRX 3597,
on 24 November 2001
near Bassersdorf/ZH

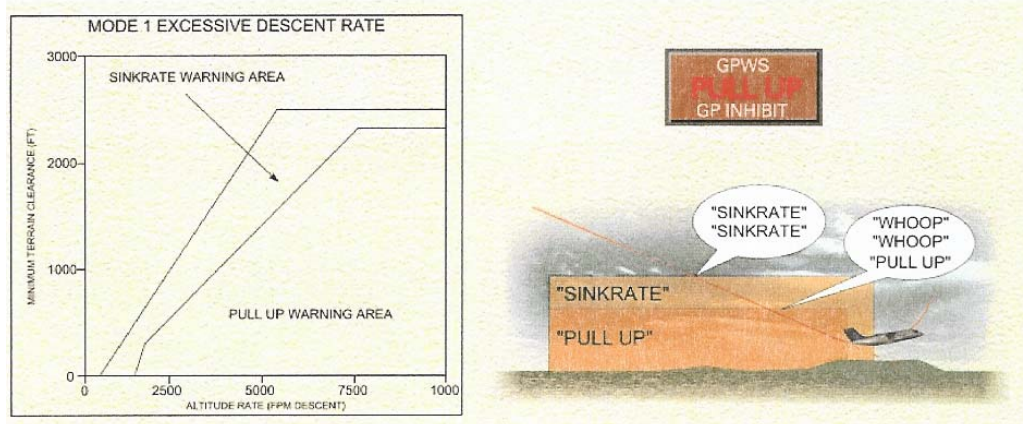
If the envelope is penetrated, the aural warning "SINK RATE" is given and PULL UP warning light on the glareshield illuminates until the envelope is left. If descent continues and the inner envelope is penetrated, the aural warning "WHOOP WHOOP PULL UP" is given. It can be seen that the PULL UP warning occurs at a higher radio altitude for higher descent rates. This is designed to provide sufficient response time for the pilot to recover.

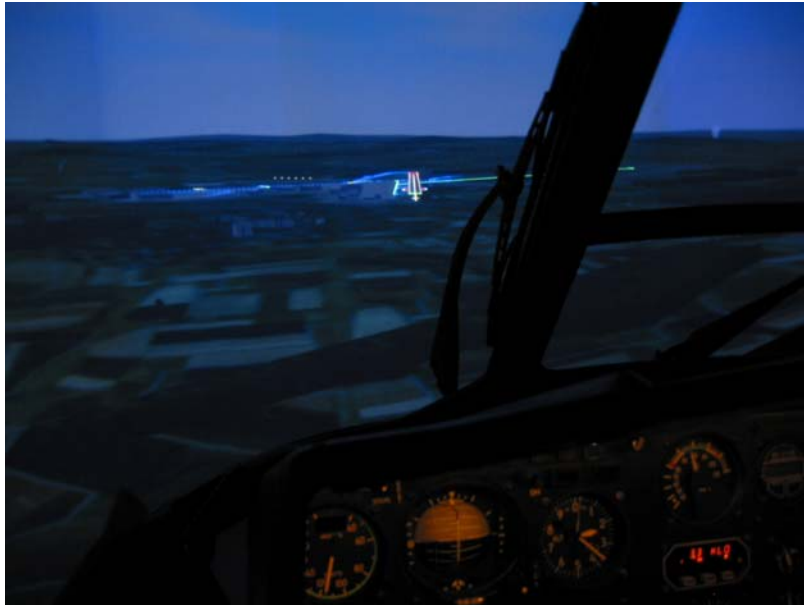
Runway 28 as seen from the Visual Descent Point (VDP) at 2390 ft AMSL by day with a visibility of more than 10 km
